Department of Construction and Civil Engineering

**INVESTIGATING THE USE OF EARTHZYME SOLUTION AS A
ROAD STABILISER IN PAVEMENT REHABILITATION: A CASE
STUDY OF A 2KM SECTION OF CHITUNGWIZA ROAD.**

A project report submitted in partial fulfilment of the requirements of the Bachelor of Science Degree in Civil Engineering.

June 2023

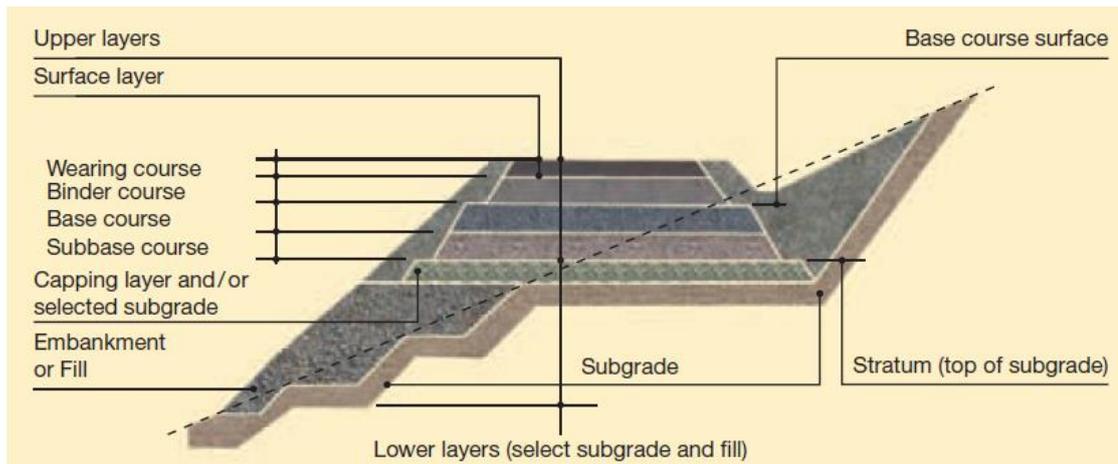
Figure 2.1: Flexible pavement layers (Wirtgen Group, 2012)

Flexible pavements are constructed in layers. Figure 2.1 shows a pictorial representation of flexible pavement layers followed by definition of the layers.

The wearing course is the surface of the road, it is the road's interface with traffic and the environment. Its function is to protect the pavement from both traffic and the environment, providing a strong and water-tight layer.

Road design states that the strongest material is placed at the top of the pavement where imposed load stresses are highest and weakest at the bottom. Traffic wheel load is distributed from the wearing course to the roadbed.

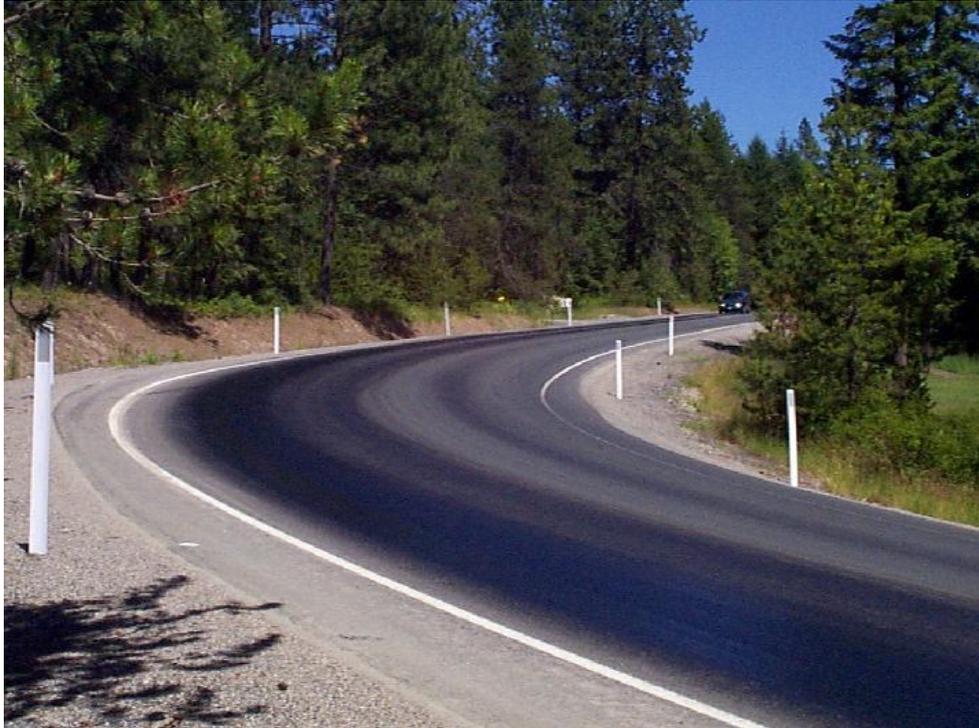
Figure 2.2: Bleeding pavement (Pavement Interactive, 2020)

Bleeding occurs when asphalt binder fills voids during hot weather or traffic compaction and expands onto the surface. This is caused by low air voids, excess prime or tack coat and/or excess asphalt. Figure 2.2 shows a road that has a bleeding distress.

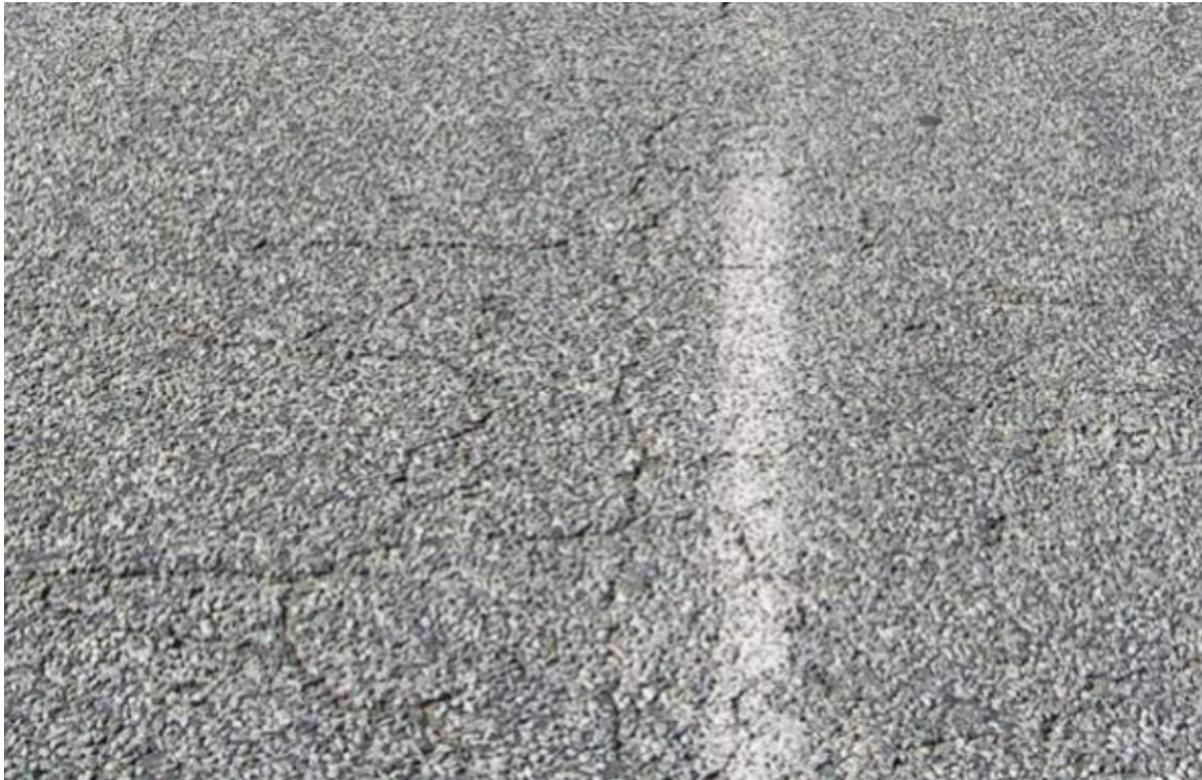
Figure 2.3: Surface cracks (Pinard & Geddes, 2020)

Environmental cracking occurs due to UV light from the sun, heat, and oxidation cause asphalt pavements to shrink forming cracks. Figure 2.3 shows cracking on the edges of the pavement.

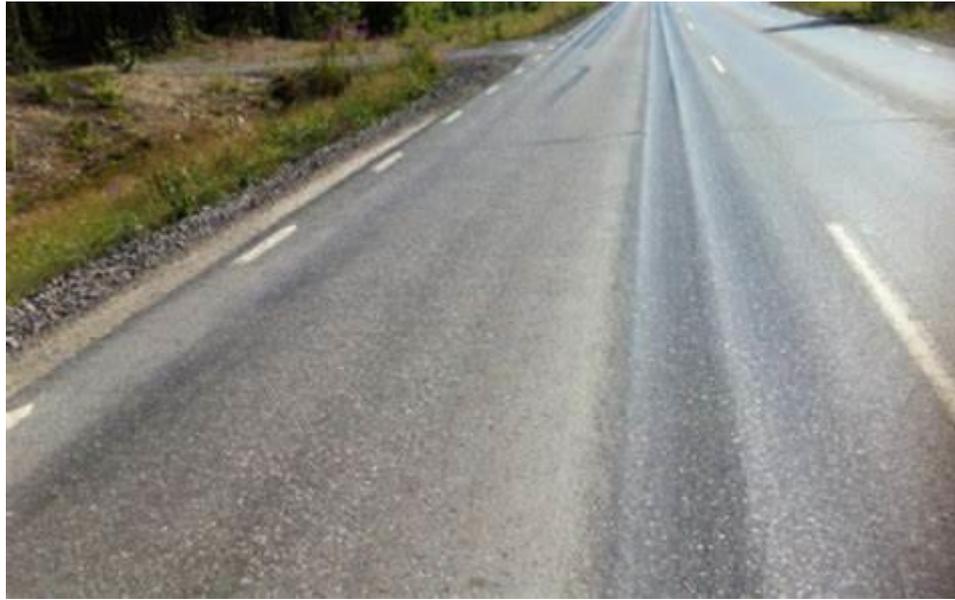
Figure 2.4: Rutting pavement (Piotr, 2021)

Ruts are channel-like depressions caused by wheel tracks as shown in Figure 2.4. As heavy traffic moves on the pavement, they start to compact the asphalt surface forming ruts. Ruts mainly form on pavements where there is lack of compaction, improper mix, insufficient layer thickness, moisture penetration and horizontal movement of layers under traffic load. Minor ruts are simply filled and provided with an overlay but in severe rutting scenarios, the damaged area is removed and replaced with a new layer.

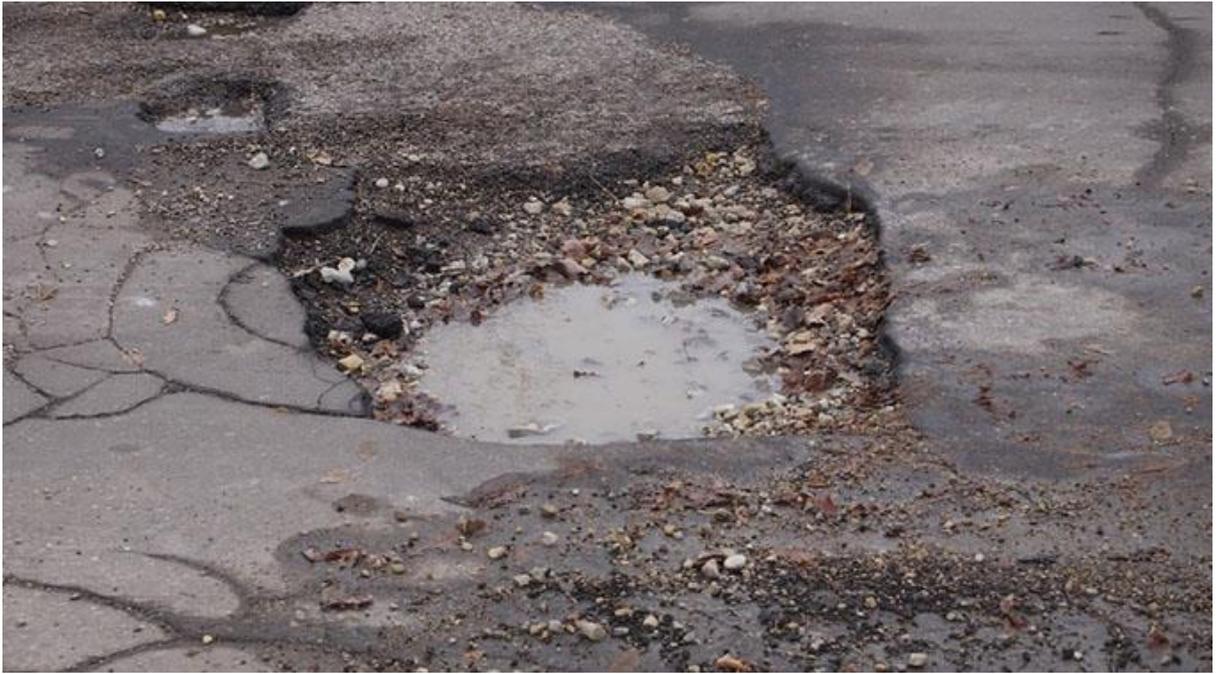
Figure 2.5: Pothole damage on road (Chidhakwa, 2020a)

Potholes are small depressions on pavements' surface that can penetrate deep up to base course. They are formed from prolonged water ingress into the pavement through existing surface cracks. Flexible pavements are highly vulnerable when they get in contact with water. Water can be in the form of diesel spillages or rainwater. Pavements fail when there is water intrusion into the pavement, due to poor drainage, through cracks formed in the pavement. During winter or cold temperatures, the water will freeze thereby increasing in volume and decrease in material density. Any temperature drop will cause the frozen water to thaw and evaporate creating a void on the surface (Naveen et al., 2018). Water is therefore the prime cause of pothole formation. Figure 2.5 shows a pavement that has failed due to potholes.

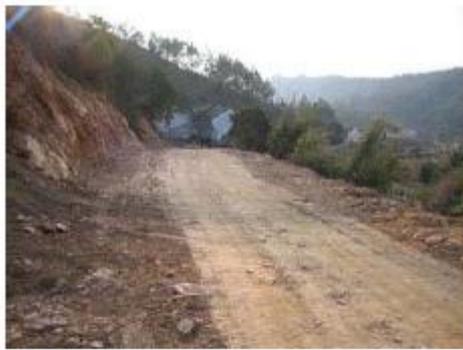
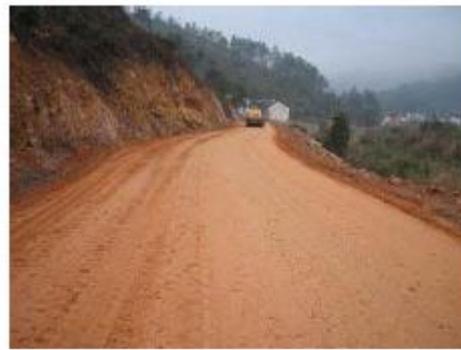
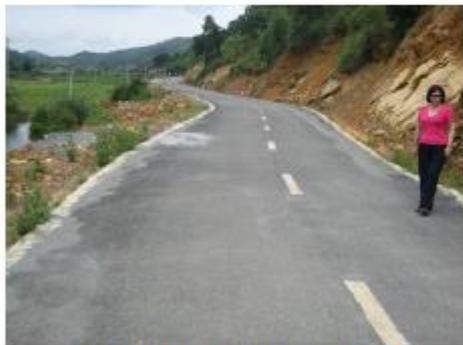
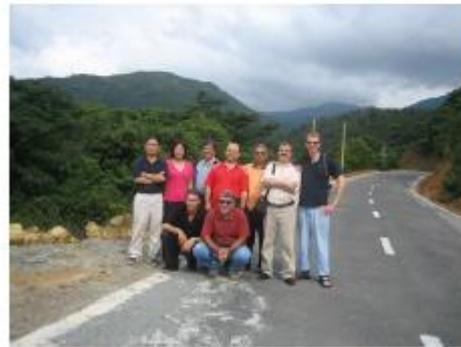
Figure 2.6: Construction of a 7.2km road constructed in Huiyang District using EZ stabiliser (Cypher Environmental, 2022).

As can be seen in Figure 2.6, a 7.2km road in Huiyang District was successfully constructed using EarthZyme solution as a road stabiliser (Cypher Environmental, 2022). The site for the road is hilly therefore the road had to be built with the assurance of long-term road base safety and support. Construction of EZ stabilised road lowered fuel consumption of vehicles by 17.4% due to the less deflection of the road. Significant dust reduction of up to more than 60% led to improved visibility of the site and reduced occupational diseases as well as potential safety hazards which were brought by high dust concentrations. The road proved that its strength and surface evenness were still satisfactory after one year. In this project, EarthZyme solution demonstrated its effectiveness beyond a shadow of doubt.

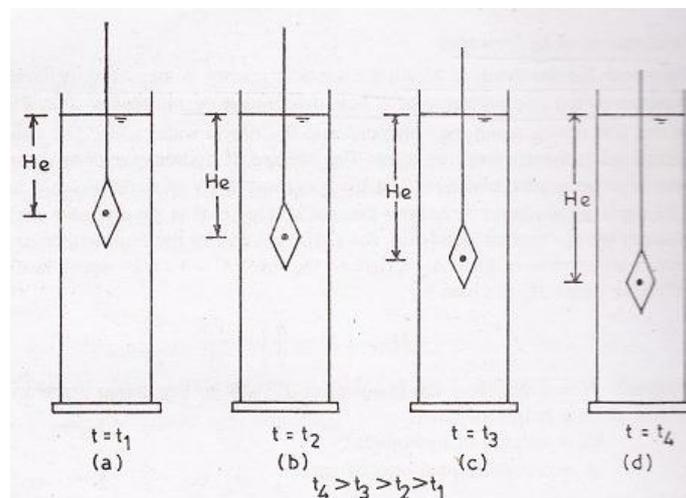
Figure 2.7: Hydrometer's downward movement with time (Gopal, 2011)

The fine-grained fraction of the coarse soil is determined by sedimentation method using a hydrometer. The hydrometer test measures the change of specific gravity of a soil-water mixture with time. The test is based on Stokes law which governs the settling velocity of spherical particles in suspension. A hydrometer is used to determine the grain size distribution of the particles falling out of suspension. Sodium hexametaphosphate is used as a dispersing agent. The specific gravity of the soil-water mixture decreases as the soil particles fall out of suspension. Strict temperature control is observed during the test. Figure 2.7 shows the movement of the hydrometer bulb with time as the particles settle.

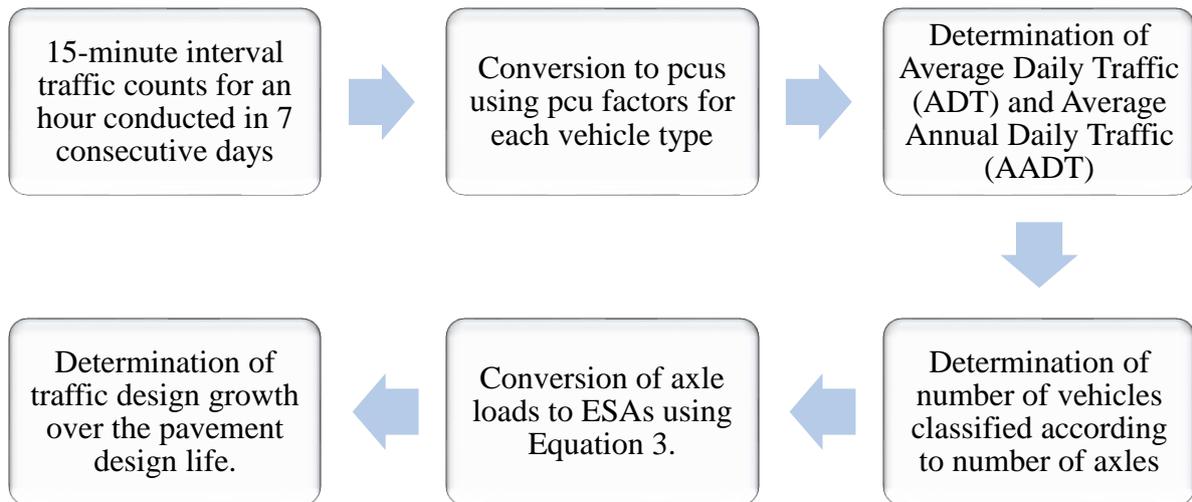
Figure 2.8: Process of estimating ESA for a road (Transport Research Laboratory, 1993).

The purpose of counting traffic is to estimate axle loads that vehicles impose on a road. These axle loads are crucial because they help in the prediction of the road damage caused by wheel loads over the design life. The process of estimating ESAs is illustrated in Figure 2.8.

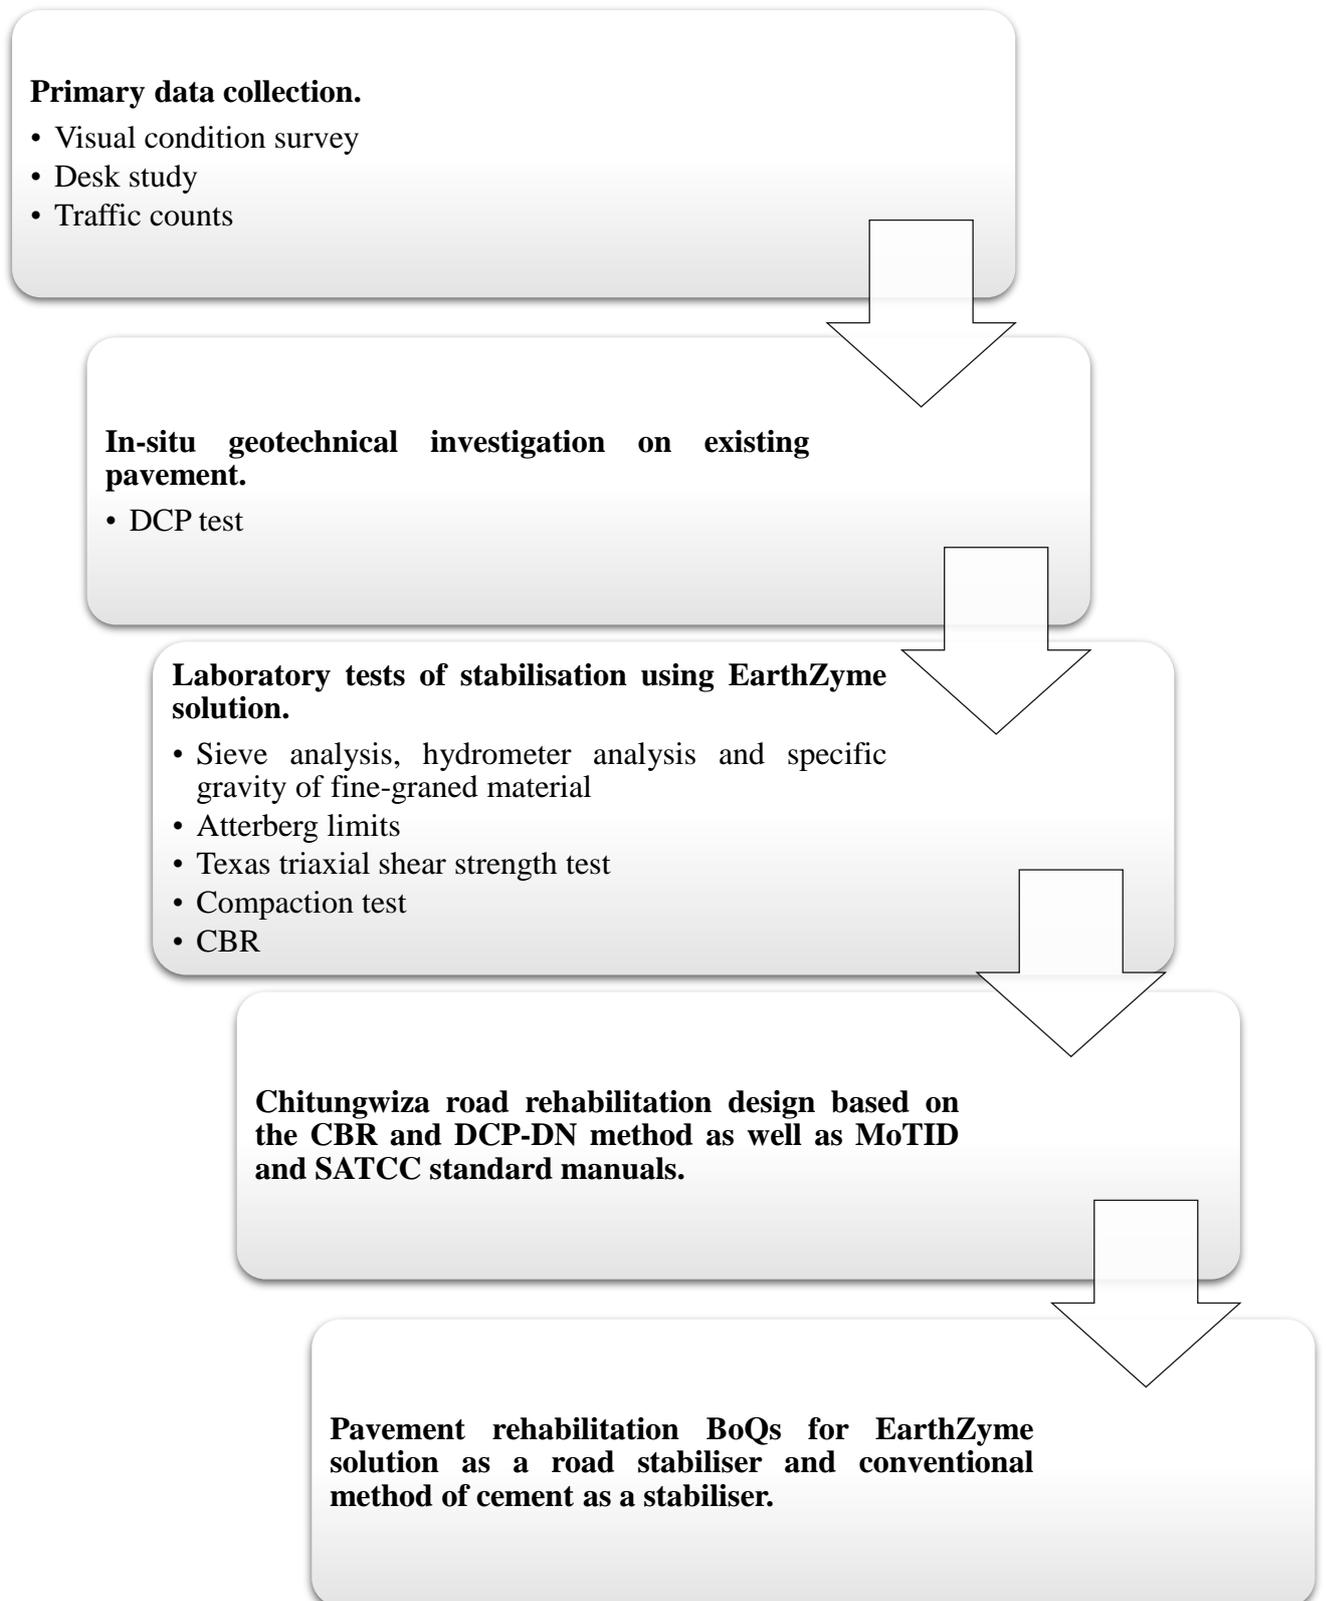
Figure 3.2: Flowchart showing the project research design

Figure 3.2 shows the flowchart of the research framework followed in executing the project.

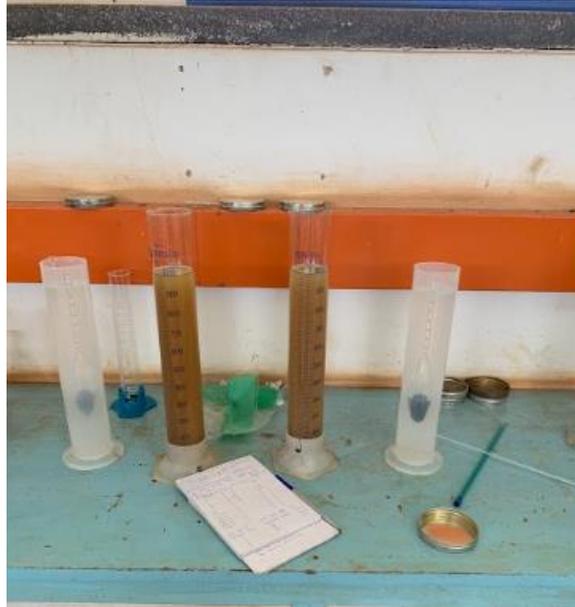
Figure 3.3: Set up of apparatus used for hydrometer analysis test.

Hydrometer test was done according to ASTM D7928-17. The aim of the test was to determine soil compatibility with EarthZyme solution by finding particle size distribution of fine-grained soils passing through 75µm sieve by sedimentation process using a hydrometer. 40mg of Sodium hexametaphosphate was dissolved in distilled water to give a litre solution which was stored in a bottle with a stopper. 50g of the soil sample which passed through the 75µm sieve was placed in a conical flask and 125ml of the dispersing agent solution was added. The solution was stirred thoroughly and allowed to stand for 24hours. The sample was then transferred without any wastage of particles to a standard hydrometer analysis cylinder. The cylinder was filled with distilled water to the 1000ml mark. A rubber stopper was placed on top of the cylinder and it was tipped, turned upside down, 30 times in one minute. The cylinder was placed on the test site and a clock was started to record the elapsed time. Hydrometer readings were recorded at 1, 2, 4, 8, 15, 30, 90, 180, 240, 480 and 1440 minutes. Figure 3.3 shows setup of the hydrometer analysis test conducted in the laboratory.

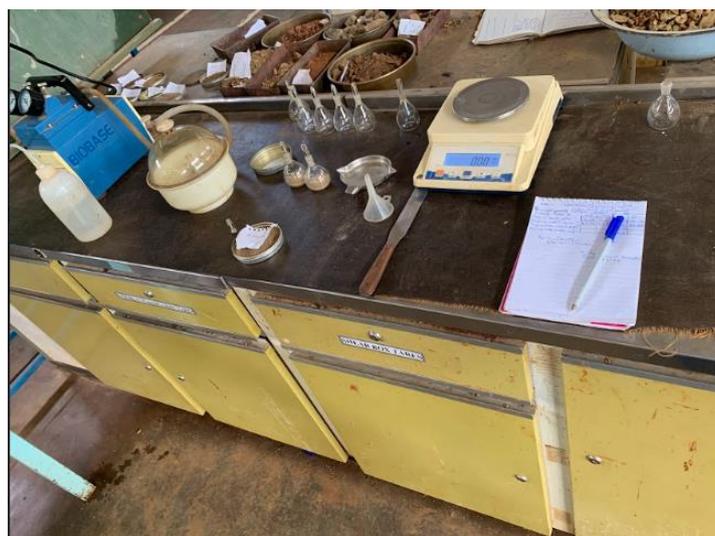
Figure 3.4: Apparatus used for specific gravity determination.

For specific gravity determination, density bottles were dried, weighed and their masses recorded. Soil sample of mass between 10-15g was placed in each density bottle and water to just cover the soil was added. The density bottles were placed in a desiccator without stoppers to remove air bubbles until there was no change on the gauge reading. Distilled water was then added to the mark on the neck of the density bottle and the bottle was weighed. The bottle was cleared and cleaned, distilled water only was added to the neck and the bottle was weighed. Specific gravity of fine-grained material was determined from the masses obtained and used during hydrometer analysis. Figure 3.4 shows the apparatus used in specific gravity determination in the laboratory.

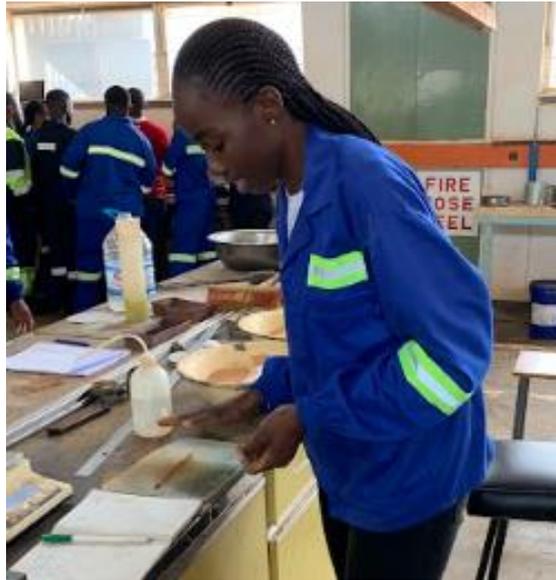
Figure 3.5: Plastic limit test.

A 20g sample that had passed the 425 μ m sieve was placed on a glass plate and mixed with water until it could be easily shaped into a ball. The sample was divided in two portions and rolled between fingers and a clean glass plate with sufficient pressure to form a thread of 3mm diameter and 150mm length as shown in Figure 3.5. The threads were broken into 6 pieces, placed in containers, weighed and placed in the oven for moisture content determination.

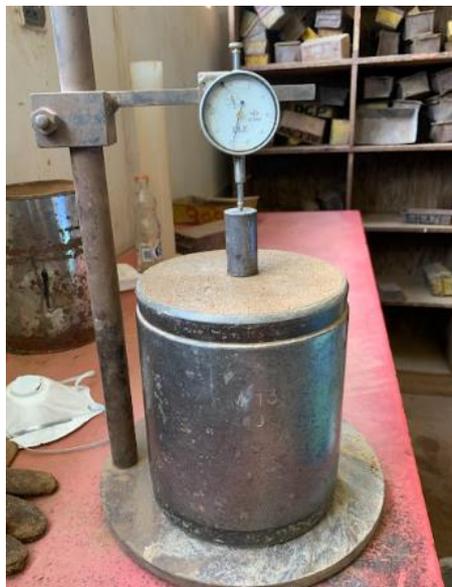
Figure 3.6: Dial gauge used to measure the height of specimen.

Triaxial shear strength test was done according to BS 1377: Part 8 (1990) manual. The consolidated undrained test was done in this project. Triaxial specimens were prepared using the trial-and-error method, at first, to determine the amount of soil required per mould which produces a compacted specimen with a height that is twice the diameter of the mould. The dial gauge used to measure the specimen height is shown in Figure 3.6.

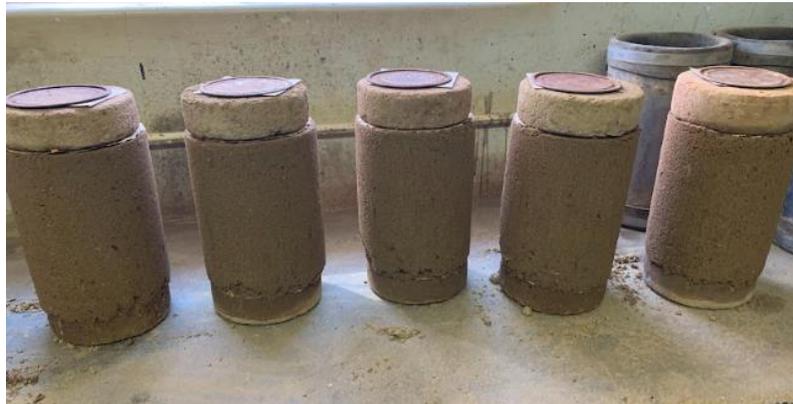
Figure 3.7: Samples prepared for triaxial shear test.

5 samples was compacted and demoulded as shown in Figure 3.7. Porous stones were placed on the top and bottom faces of each specimen.

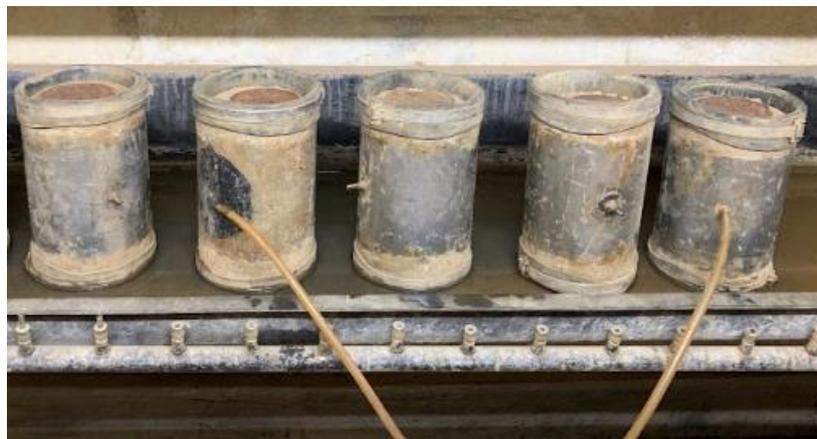
Figure 3.8: Saturation stage where samples were left to soak in a water bath.

These specimens were consolidated under all round pressure before failure which was achieved by covering the samples with, first, a permeable membrane and, second, a rubber membrane. The samples were then soaked in water for 10 days. Figure 3.8 represents how the samples covered with membranes and saturated in a water bath. Saturation is done to ensure that pore water within the sample does not contain air (BS 1377, 1990b).

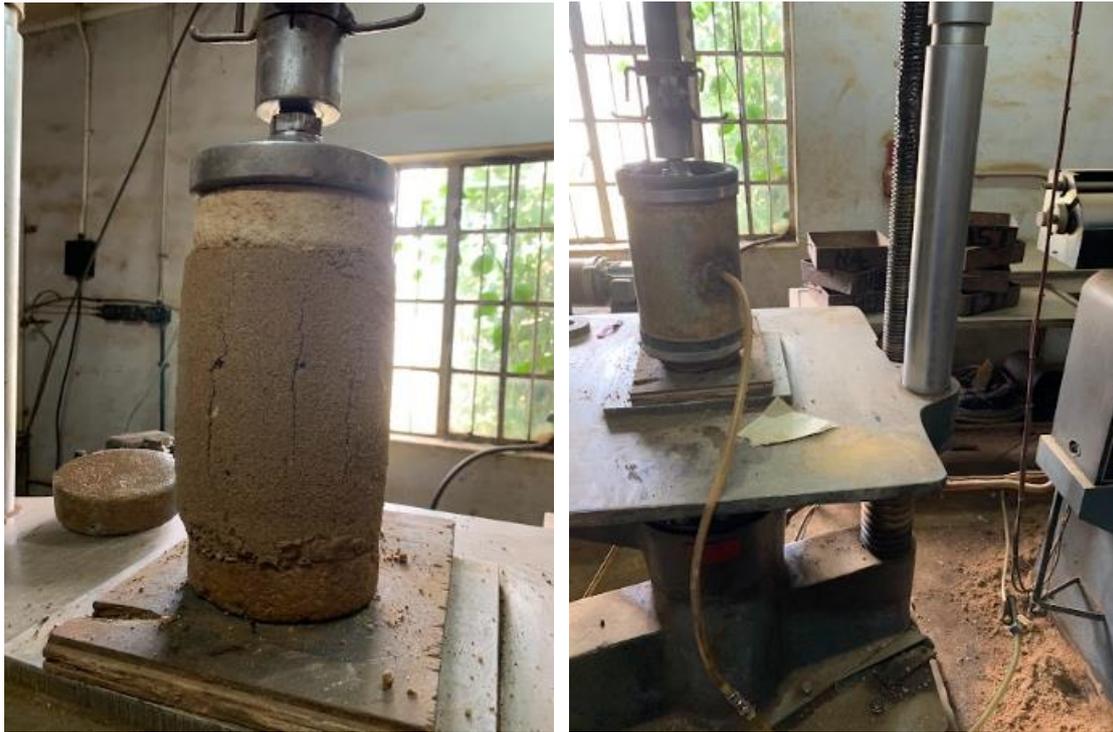
Figure 3.9: Triaxial test compression stage

After the saturation stage, the compression stage followed. Figure 3.9 represents how the samples were compressed and the axial stress was recorded at failure that is when the deformation dial gauge stopped. 2 specimens were exposed to zero confining pressure and the remaining 3 samples to different confining pressure.

Using the results, Mohr-Coulomb plot is drawn for the failure conditions and shear strength parameters, cohesion and angle of shearing resistance, are ascertained.

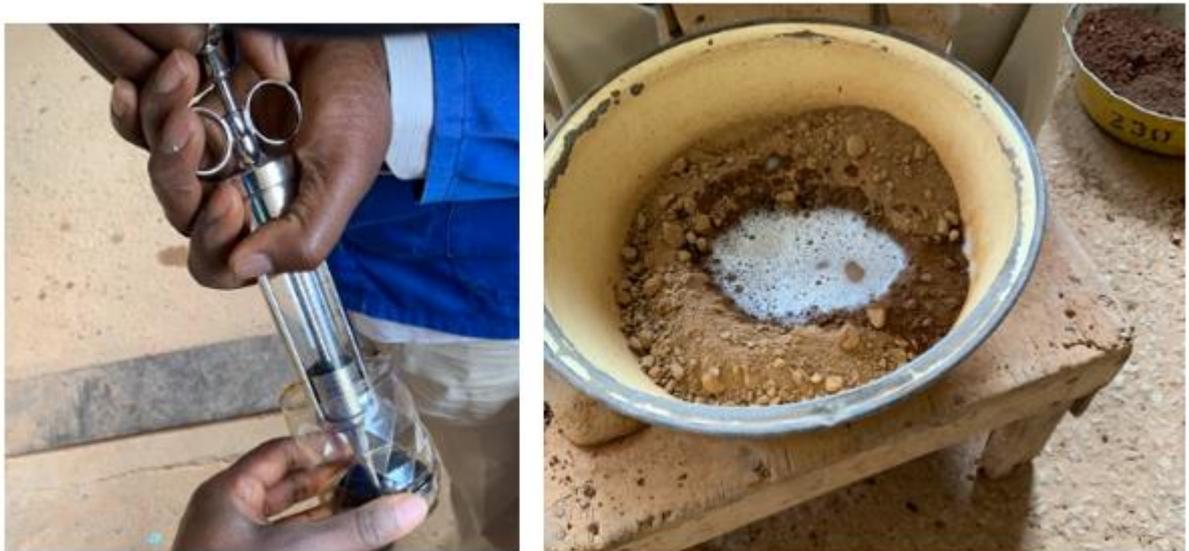
Figure 3.10: Measurement of 1ml of EarthZyme road stabiliser and its addition to water in the soil sample during compaction.

Samples at 0.5m depth from TP1 and TP2 were compacted. Control samples were compacted with water only and treated samples were compacted with water mixed with EarthZyme solution as shown in Figure 3.10. Treated samples with EarthZyme solution used the ratio of 1litre of EarthZyme solution as to 33m³ of compacted soil (Cypher Environment, 2009). The samples were cured for 7 and 28 days. Comparative, dry and soaked, CBR tests were done to determine the strength development of the stabilised sample with time. For soaked CBR test, the moulds were soaked for 96 hours (4days) prior testing.

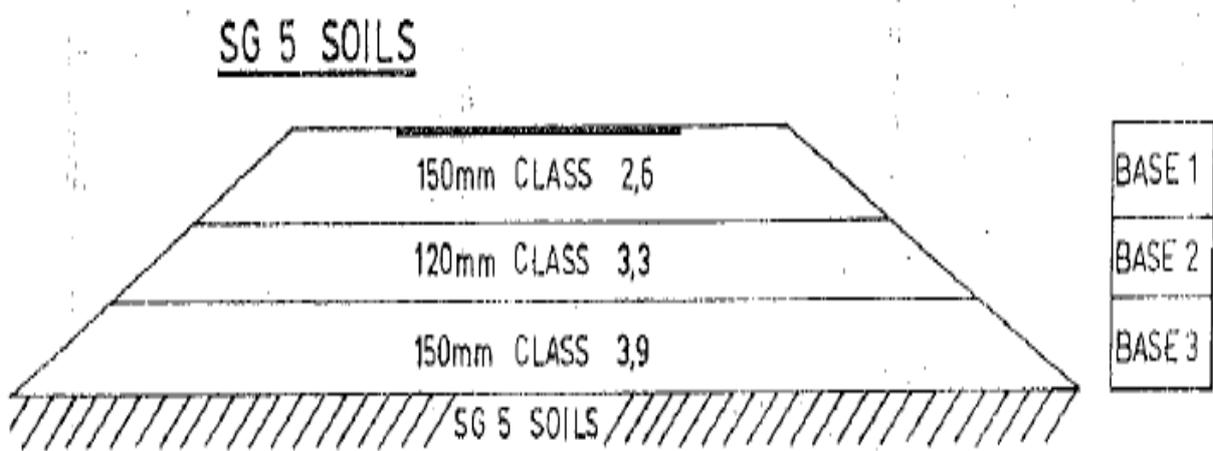
Figure 3.11: Pavement structure for design traffic of 0.3-1 million E80 (Ministry of Transport and Energy, 1989b).

Ministry of Transport standards. The pavement structure was chosen according to design traffic for the road as shown in Figure 3.11.

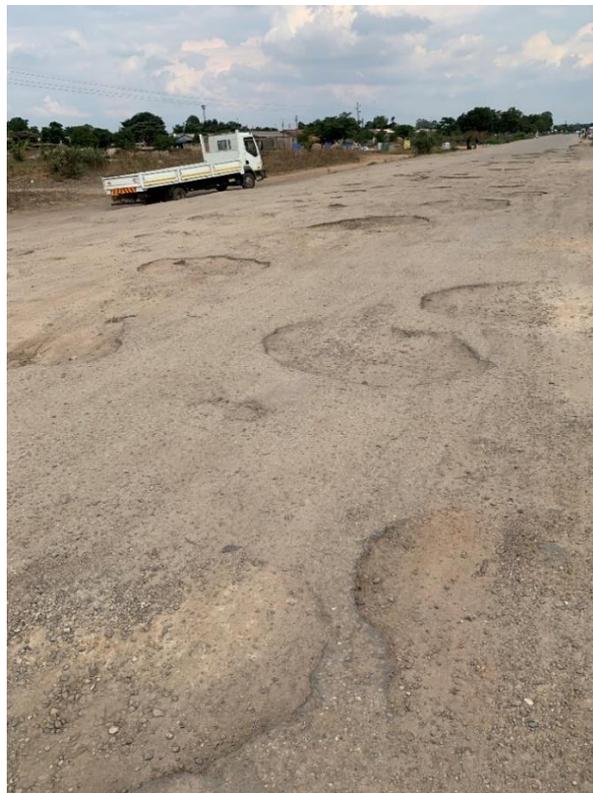
Figure 4.1: Chitungwiza road severely damaged with potholes, lorry navigating on sidewalk (Source: Author)

Figure 4.1 shows the visual condition of Chitungwiza road. Traffic is moving on the sidewalk of the road because the traffic lanes are unnavigable due to the presence of extensive potholes. Other pictures showing the condition of the road are presented in Appendix 2.

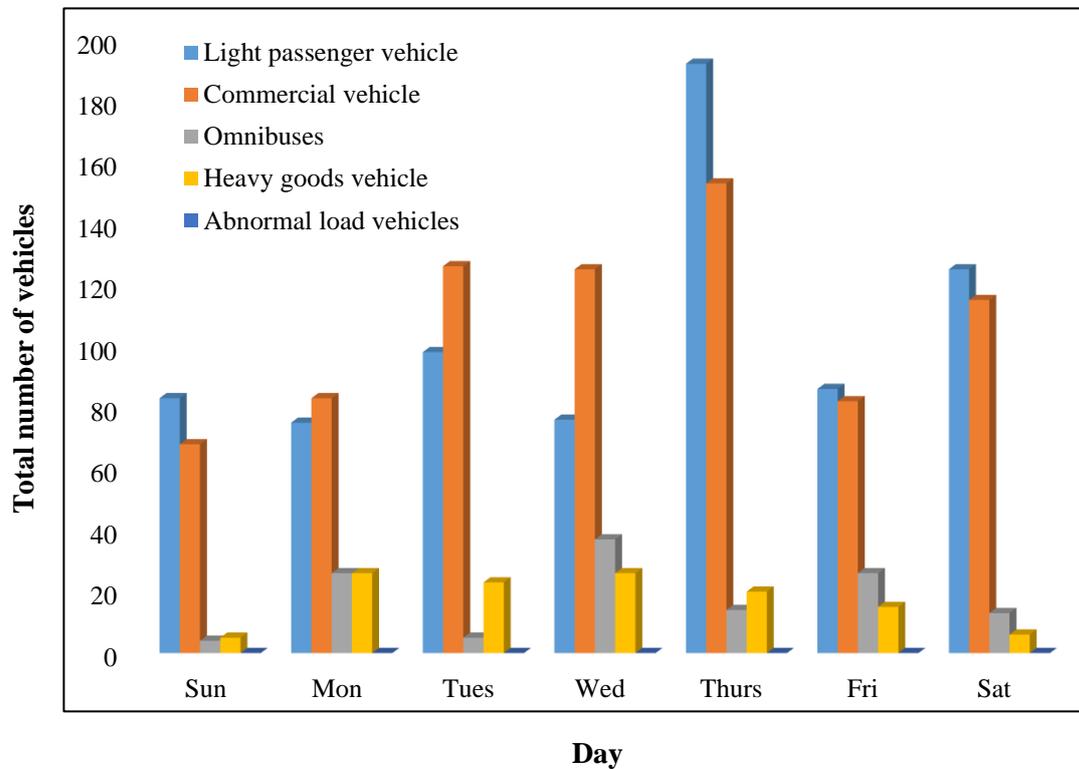
Figure 4.2: Composition of observed traffic.

$$\begin{aligned}
 \text{AADT} &= \text{ADT} \times 365 \\
 &= 1153 \times 365 \\
 &= 420\,845 \text{pcu/year}
 \end{aligned}$$

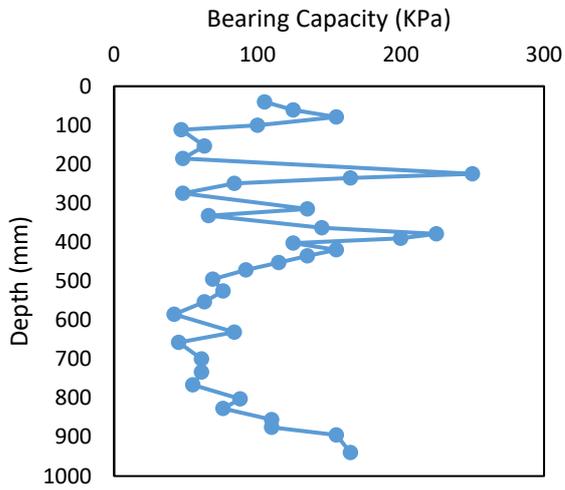
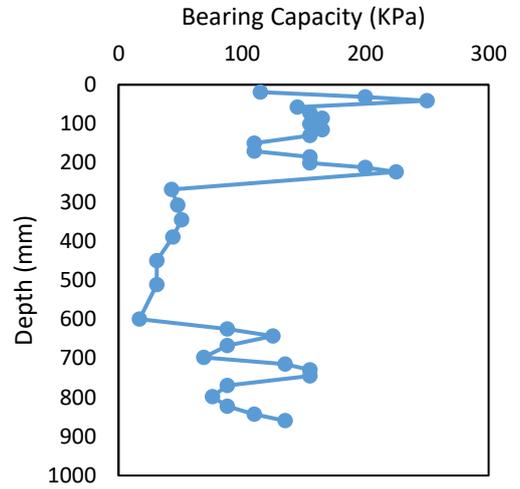
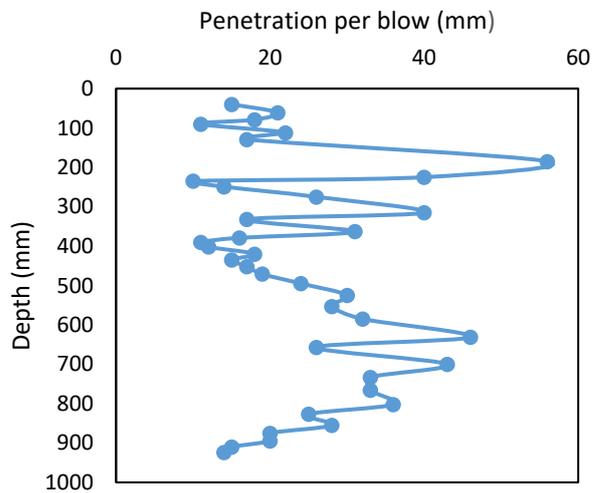
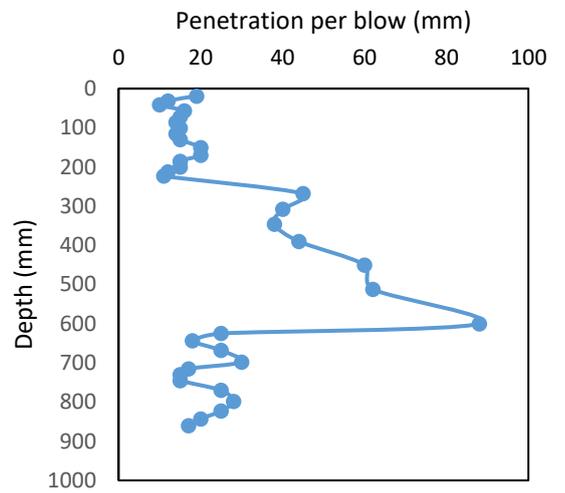
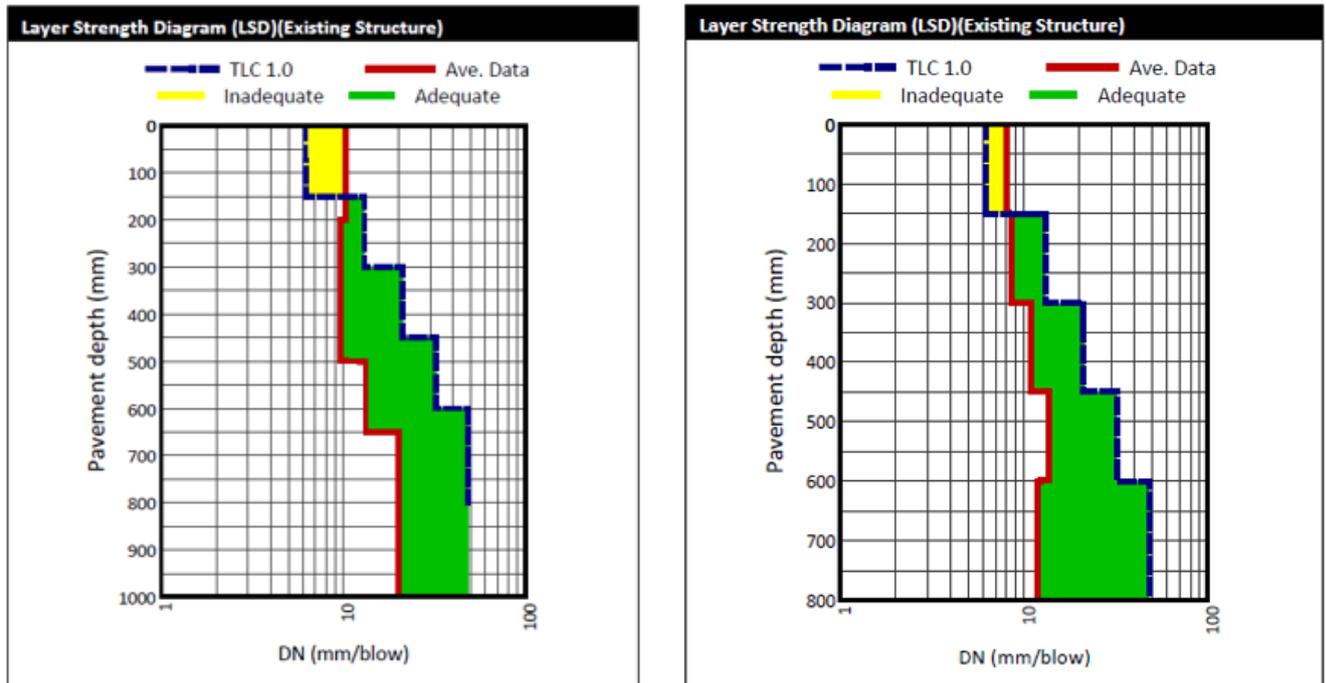
Figure 4.3: Graphs showing variation of in-situ strength with depth for each trial pit.

Variation of bearing capacity with depth.

Variation of penetration per blow with depth.

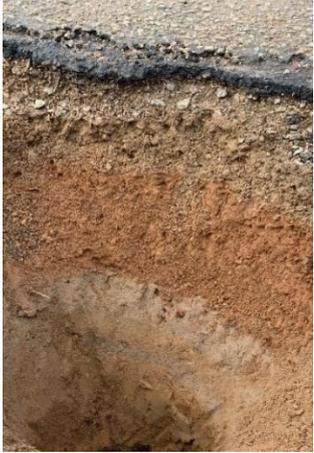
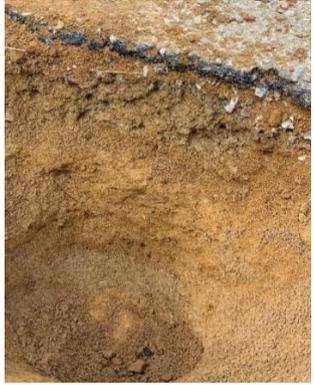
Trial pit code	Depth (m)	Description (Colour, soil type)	Moisture Content	Profile image
TP1	0	Grass on shoulders	Moist

0 - 0.2	Imported brown gravel soil	Moist	
	0.2 - 0.5	Imported dark red gravel	Moist	
	0.5 - 0.65	Light grey silty sand soil	Moist	
	0.65 - 1	Dense brown loam soil	Moist	
	>1	Black soil	Moist	
TP2	0	Eroded top soil on shoulders	Moist

0 - 0.2	Imported gravel	Moist	
	0.2 - 0.5	Light brown imported gravel	Moist	
	0.5 - 0.65	Silty grey soil	Moist	
	0.65 - 1	Light brown loam soil	Moist

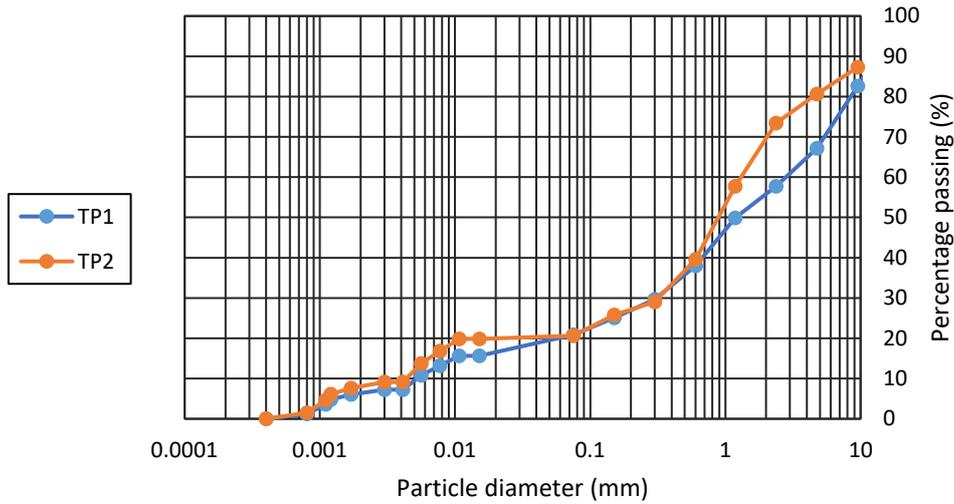
Figure 4.4: Particle size distribution curves for samples taken at 0.5m depth from both trial pits.

Figure 4.4 and 4.5 are particle size distribution curves for TP1 and TP2 at 0.5m and 1m depths. The values were found from the sieve and hydrometer analysis tests as well as the specific gravity test conducted in the laboratory. Detailed results are found in Appendix 4b.

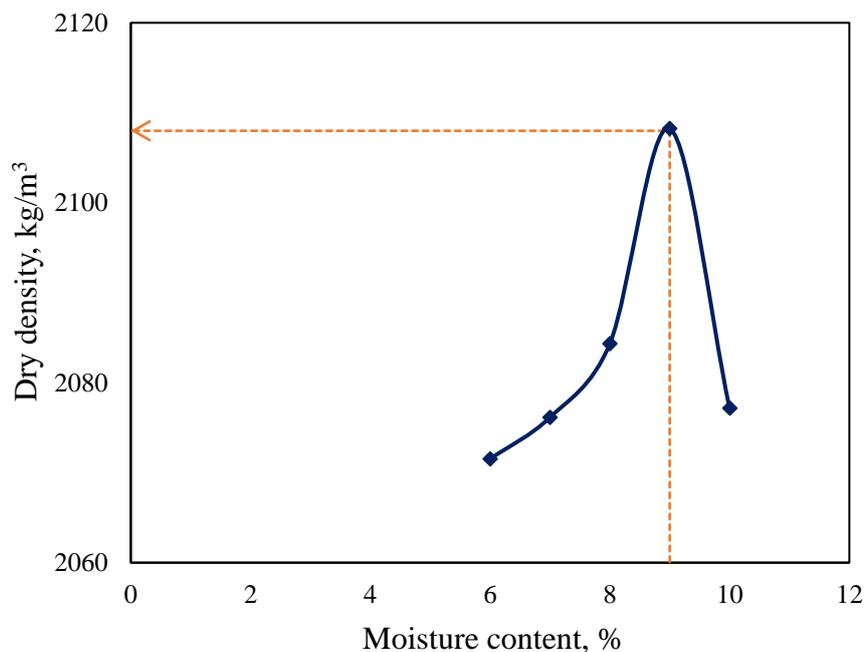
Figure 4.6: Compaction curve to determine optimum moisture content for triaxial test.

Figure 4.6 shows the compaction curve drawn during the determination of the optimum moisture content to use during triaxial test.

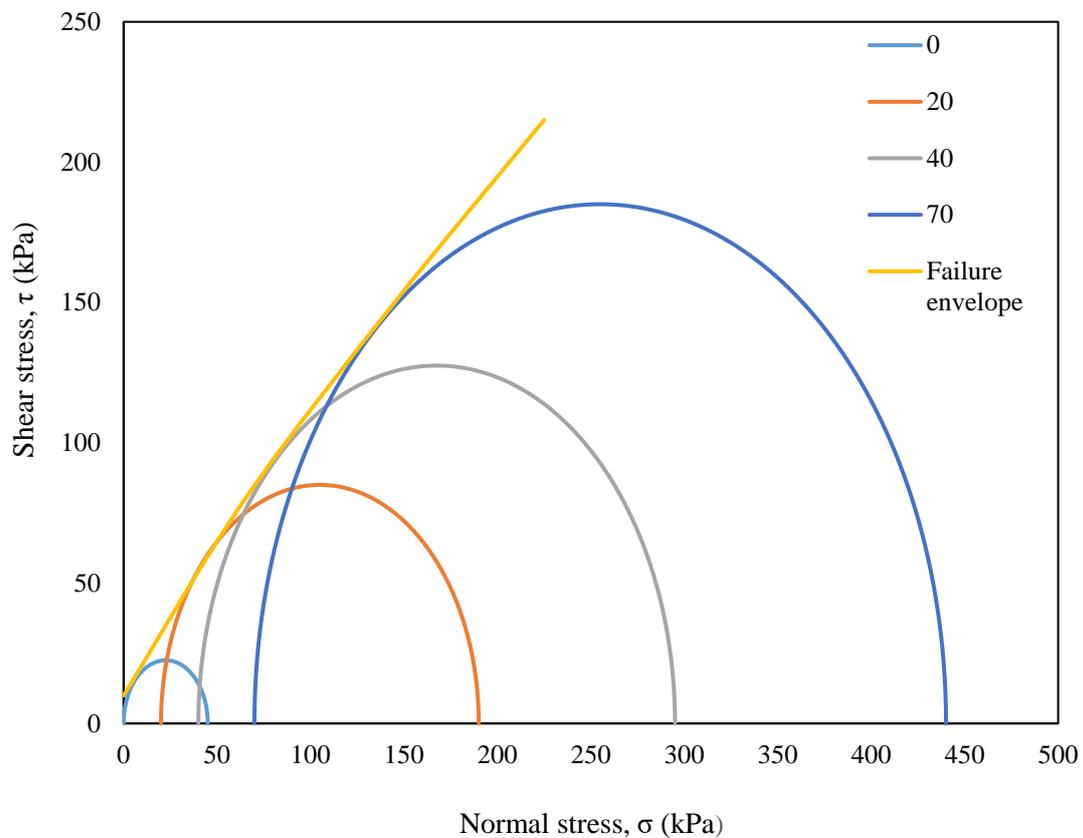
Figure 4.7: Mohr-Coulomb plot of triaxial test

Specimen number		1	2	3	4
Axial stress	σ_1	45	190	295	440
Cell pressure	σ_3	0	20	40	70
Radius	$(\sigma_1 - \sigma_3)/2$	22.5	85	128	185
σ_{avg}	$(\sigma_1 + \sigma_3)/2$	22.5	105	168	255

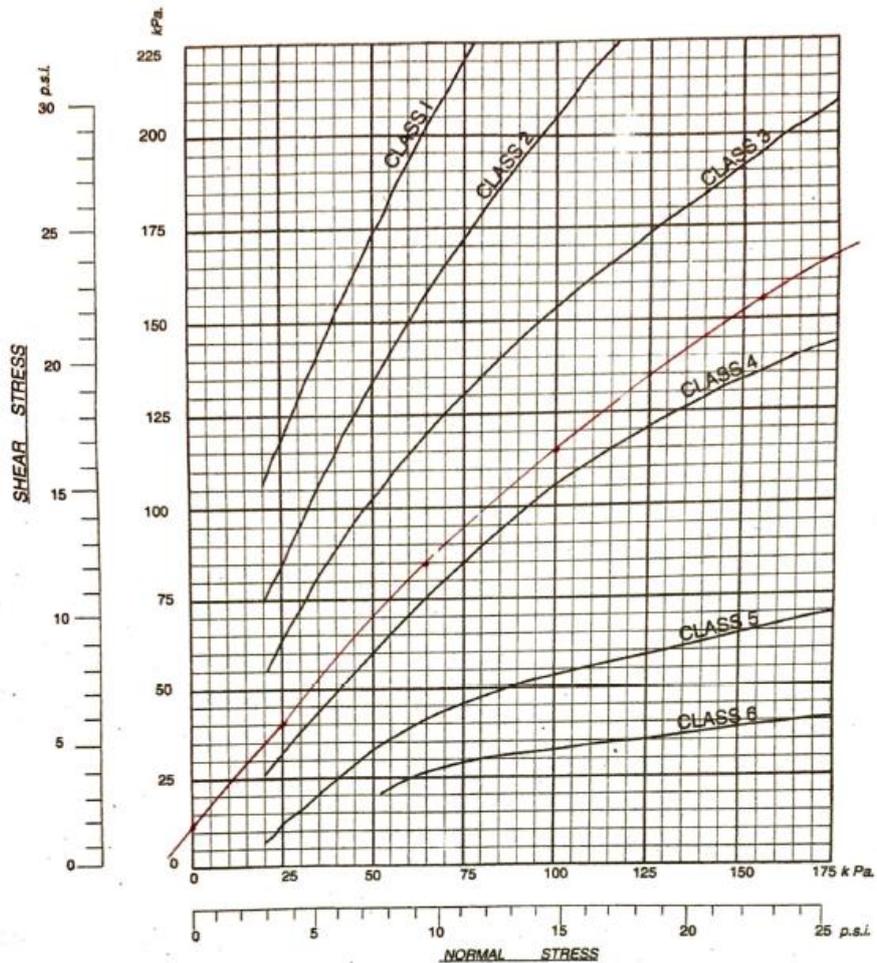
Figure 4.8: Ministry of Transport triaxial classification chart.

The failure envelope was reproduced on a Ministry of Transport triaxial classification chart as shown in Figure 4.8.

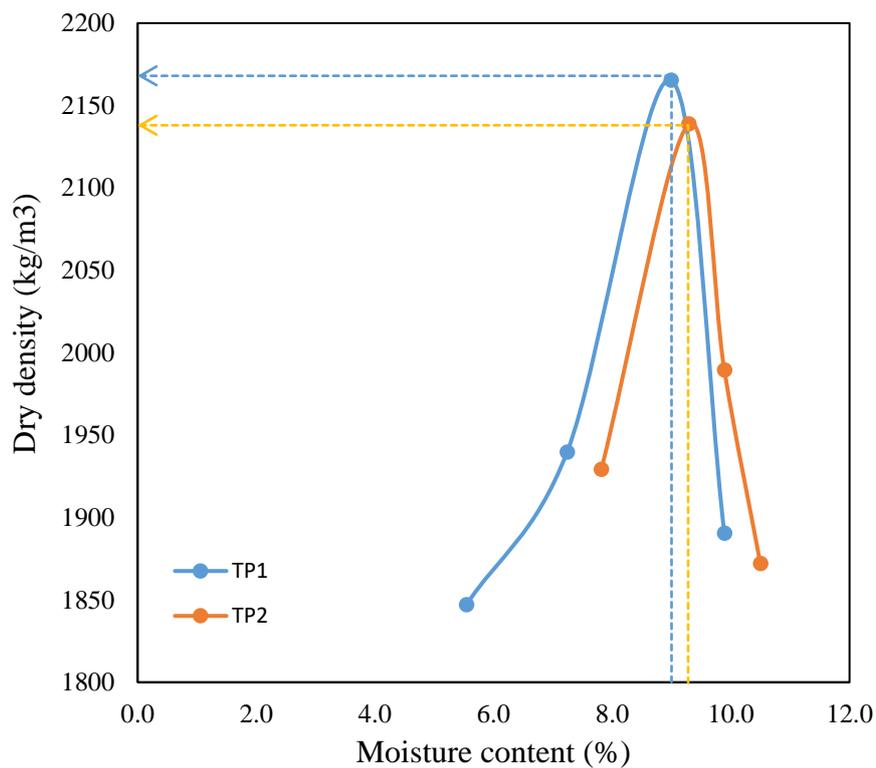
Figure 4.9: Graph showing variation of dry density with moisture content.

Results obtained during compaction test are presented in Appendix 4e. These results were plotted on a graph shown in Figure 4.9 and the optimum moisture content was determined at maximum dry density.

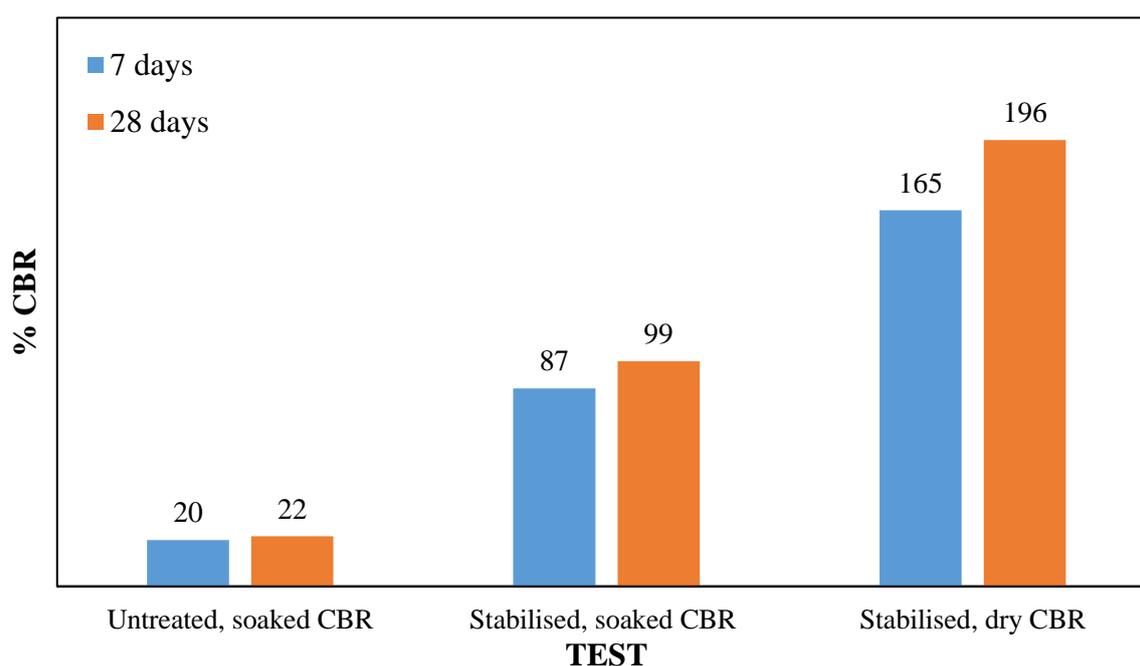
Figure 4.10: Variation of dry and soaked CBR tests for samples with and without stabiliser.

Test	7 days	28 days
Untreated, soaked CBR	20	22
Stabilised, soaked CBR	87	99
Stabilised, dry CBR	165	196
