Department of Construction and Civil Engineering

**INVESTIGATING THE USE OF EARTHZYME SOLUTION AS A
ROAD STABILISER IN PAVEMENT REHABILITATION: A CASE
STUDY OF A 2KM SECTION OF CHITUNGWIZA ROAD.**

A project report submitted in partial fulfilment of the requirements of the Bachelor of Science Degree in Civil Engineering.

June 2023

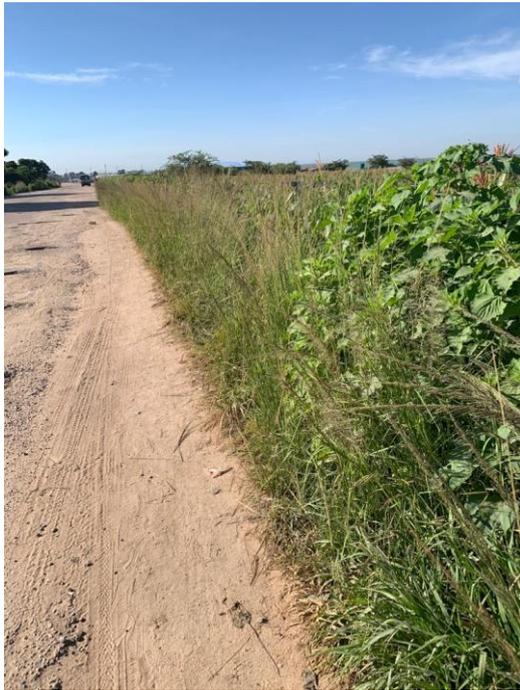
Overgrown vegetation on shoulders

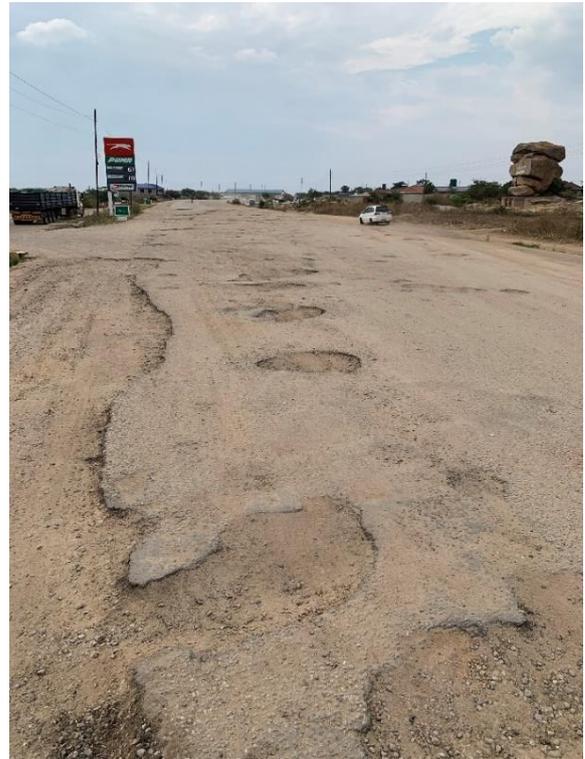
Edge defects and potholes

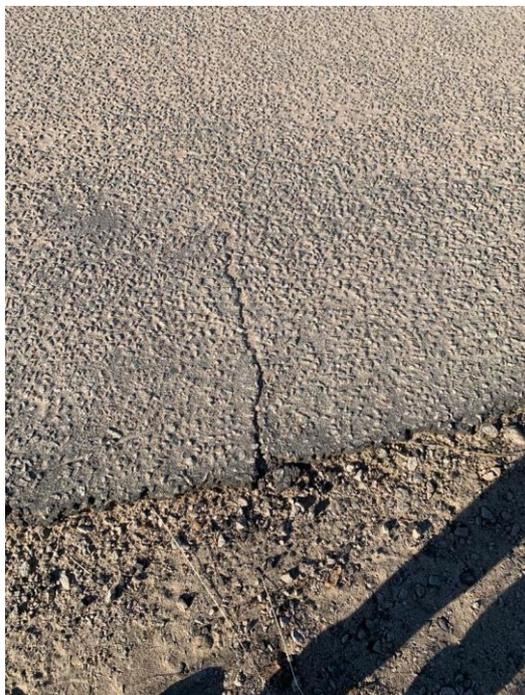
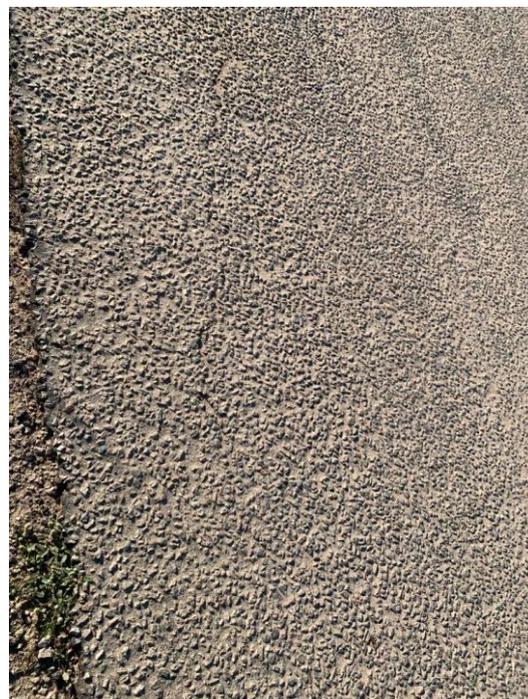
Edge cracks

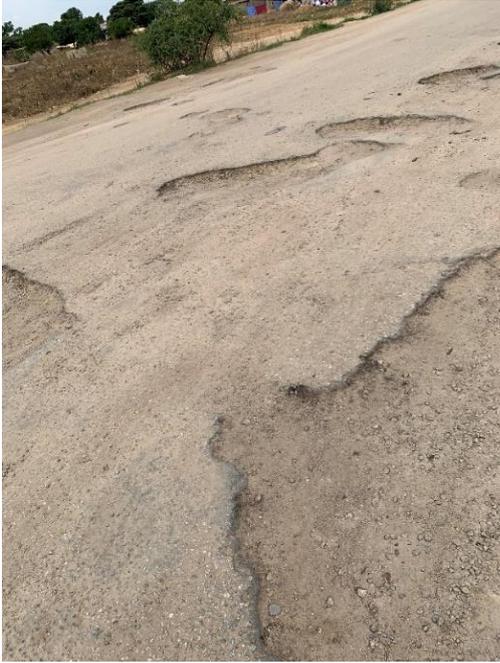
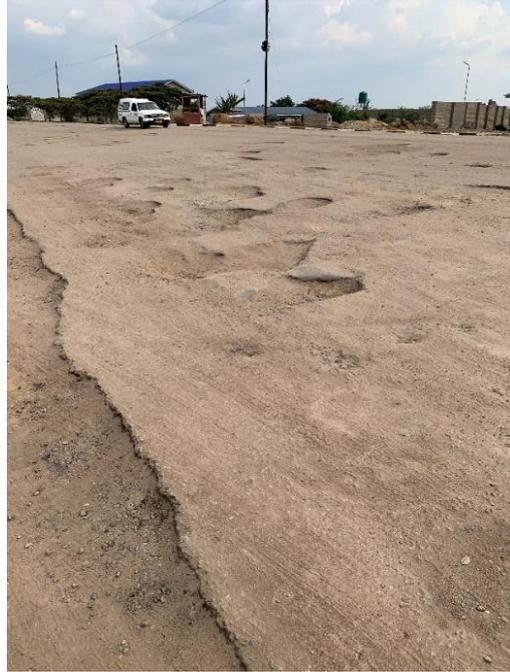
Surface failures (Aggregate loss and potholes)

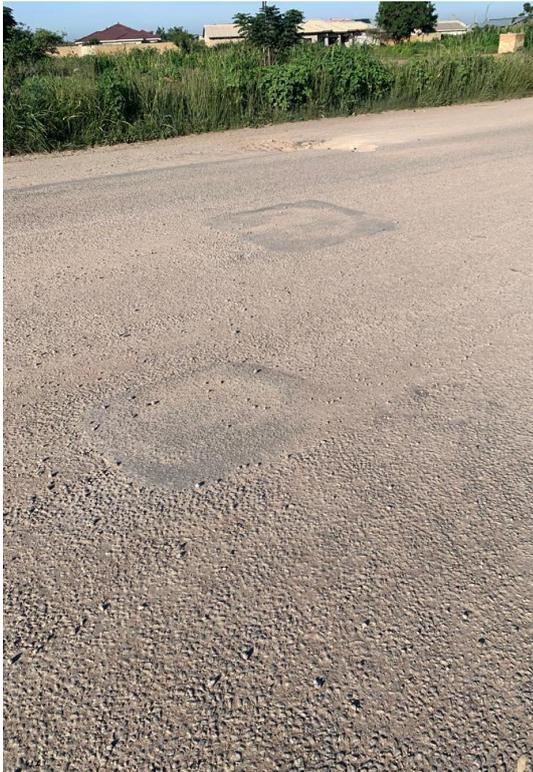
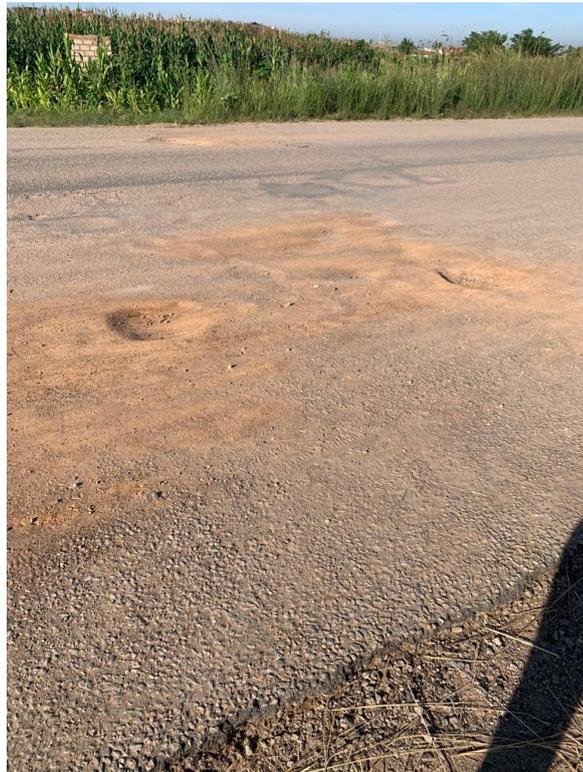
Surface patching with asphalt and with gravel

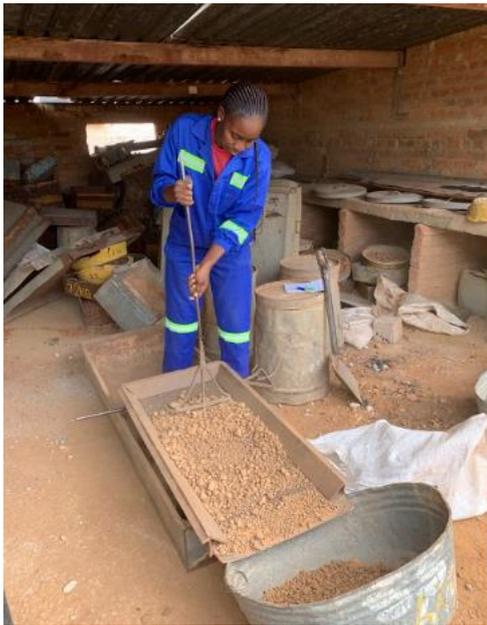
Screening the sample (separating fine material from coarse) in preparation for backmixing and testing

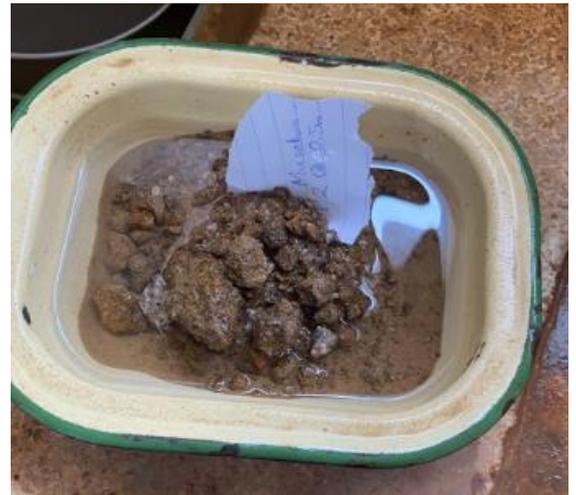
Wet sieved sample after washing ready to be oven dried.

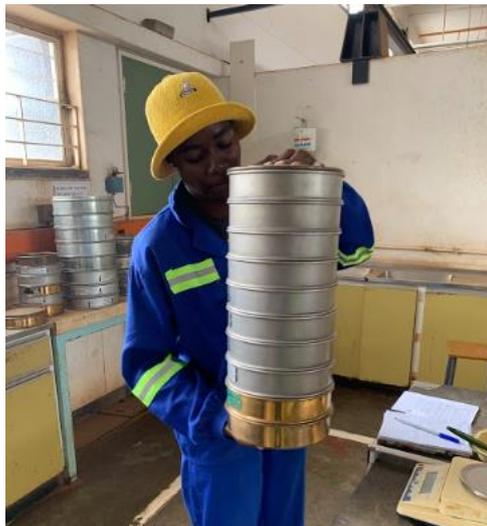
Dry sieving done in the laboratory with a series of BS sieves

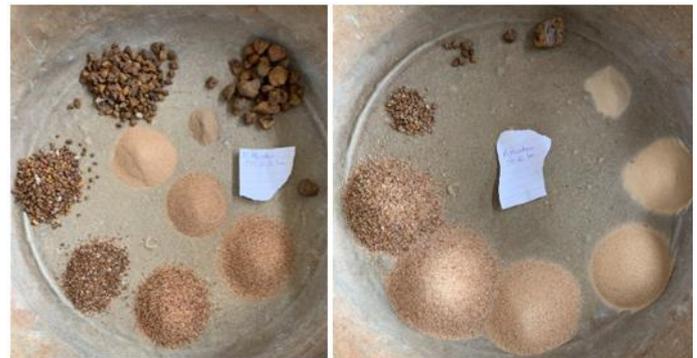
Particle size distribution of samples after dry sieving
(At 0.5m & 1m depth)

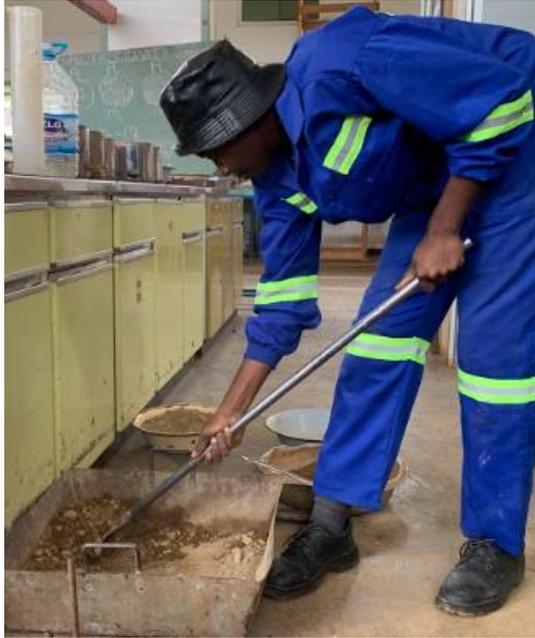
Preparation of sample for compaction.

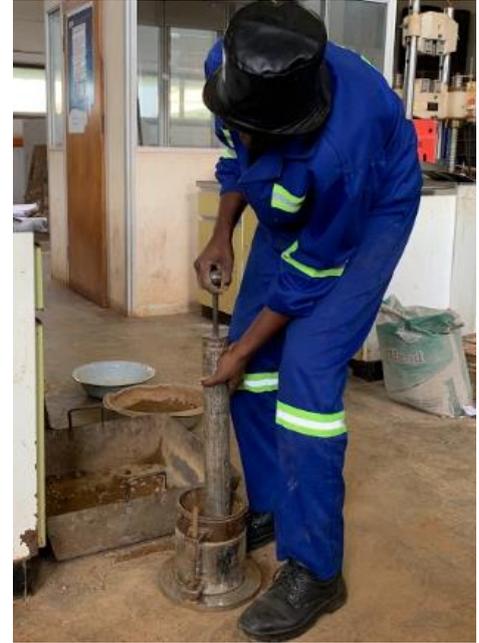
Compaction of samples to low compactive effort (LCE)

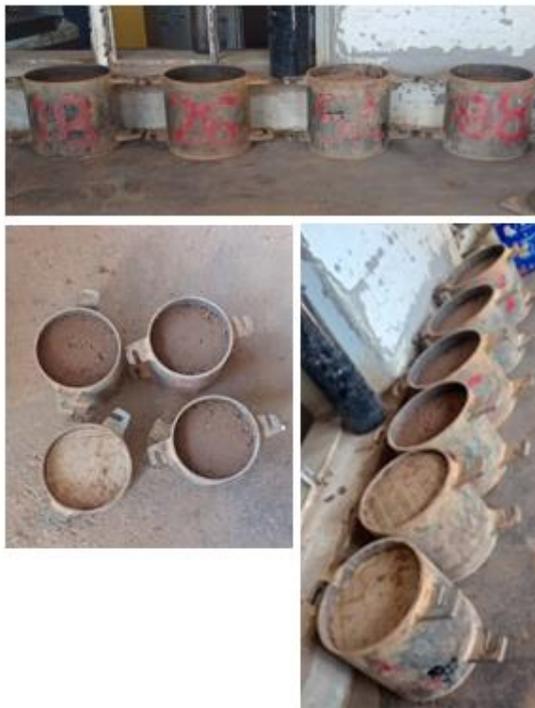
Control and treated samples compacted and left to cure for 7 and 28 days.

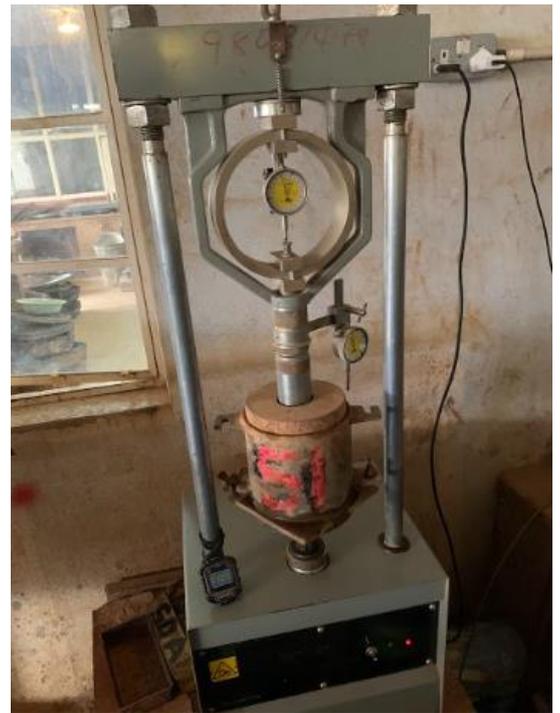
The CBR machine used for strength determination of both the dry and soaked compacted samples, treated and untreated
